SOME SLOPE MOVEMENT PROBLEMS IN WINDSOR COUNTY, VERMONT, 1984

Charles A. Baskerville and Gregory C. Ohlmacher

Open File Report 87-349

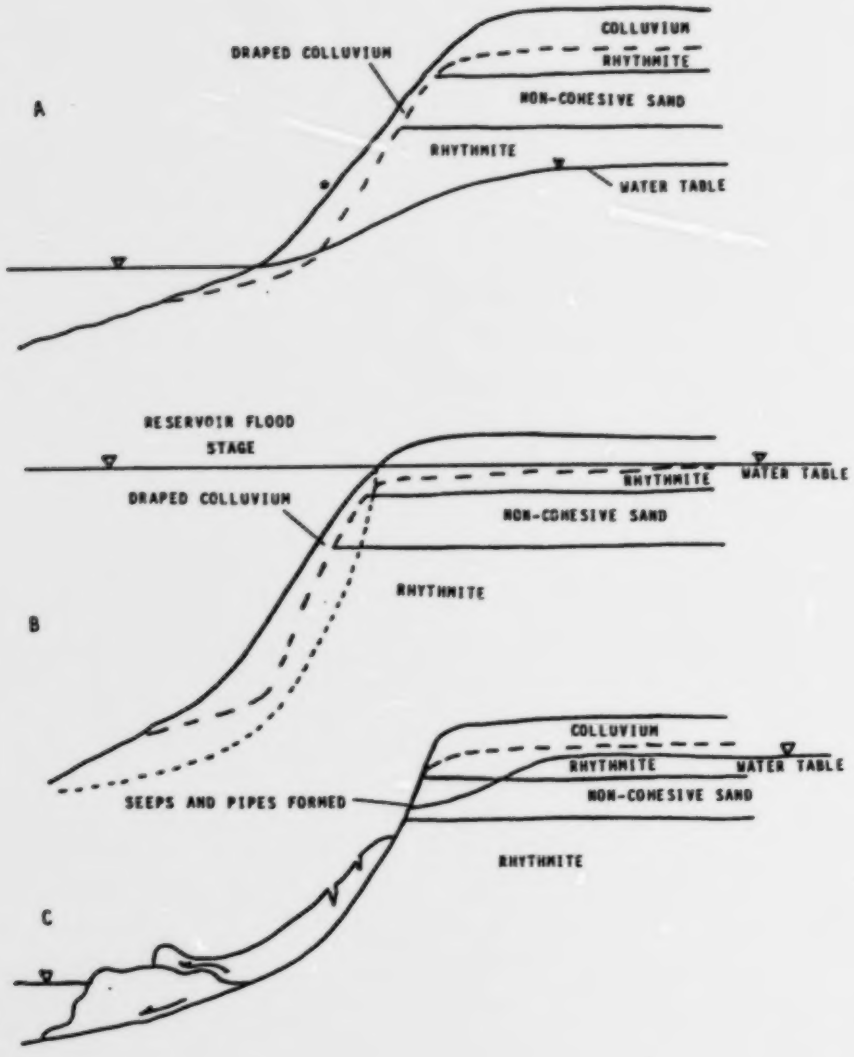
Figure 4. Schematic cross sections of a typical flood reservoir slope configuration in which earth flow and piping failures have developed. A - pre-flooding configuration; B - flood stage; C - post-slide and piping configuration.

Of the many landslides that occurred on the southwest valley wall of the North Hartland reservoir, one in particular, just west of the boat ramp parking lot had piping associated with the failure (Fig. 6). The site, a terrace, consisted of a rhythmite sequence, covered by a layer of colluvium. Near the top of the terrace, the rhythmite sequence was interrupted by a 4 foot (1.2 m) thick medium sand layer. The non-cohesive sand layer, having had a higher hydraulic conductivity than the surrounding rhythmites, acted as a confined aquifer as shown in Fig. 4.

The slope failed as an earth flow, which was partially fed by water from the confined sand layer as well as from the saturated colluvium (Fig. 4). The material involved in the failure included the colluvial cover along the slope face as well as some of the rhythmite sequence. It moved as a rapid fluid earth flow across a stream channel and was stopped by the parking lot embankment (see foreground of Fig. 9). The failure removed

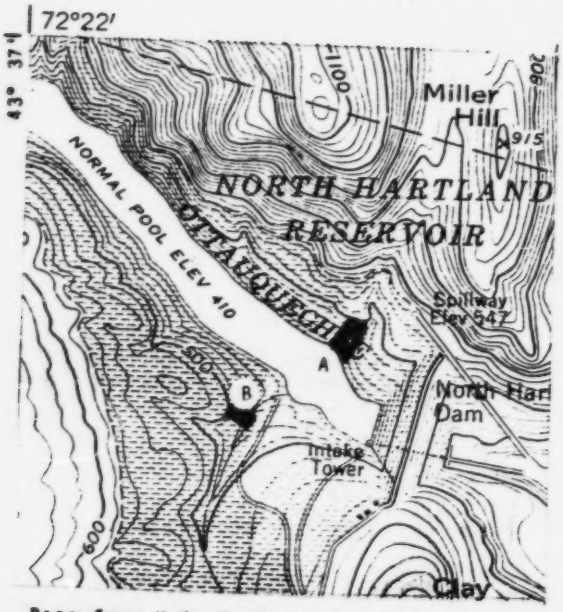
the colluvial cover, exposing the confined sand layer, which allowed the remaining water to escape from this layer. Since the sand had lower cohesion than the surrounding rhythmites, sand was removed by the escaping water. Pipes as much as approximately 4 feet in diameter (1.2 m), developed (Fig. 9 at A). Most of this movement occurred in rapid succession; with the initial earth flow followed closely by the piping phase.

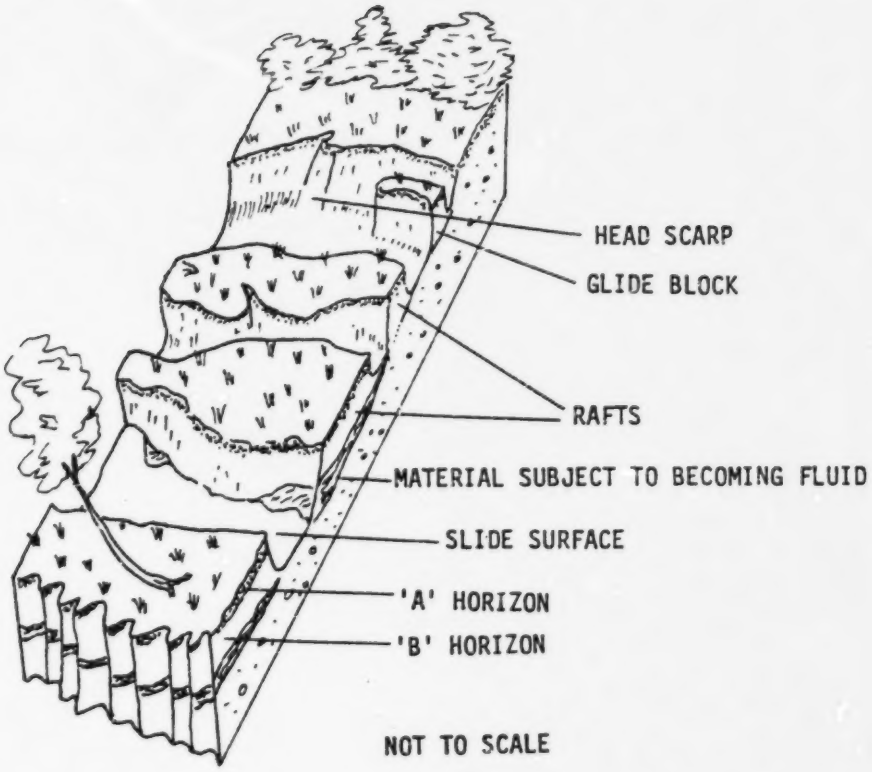
In the upper part of the slide mass near the head scarp, the basal zone of liquified material pinched out and was replaced by a planar failure surface (Fig. 8). In the headscarp area of these earth flows some small minor rotational slumps were seen that were separate from the main failure mass.

Failure in both earth flows appeared to have occurred as rafts of intact material riding on layers of fluidized material. Some of the tension cracks referred to above were caused by the extension of the failure mass as discussed previously, but others could have been caused by the bulging and buckling of the surface of the slide mass in the toe area as material piles up.

Figure 8. A block diagram showing rafts of intact material sliding on a fluidized substrate which pinches out headward. The failure surface above the pinchout point becomes a planar frictional surface. This friction creates a pulling apart of the slide material on tension cracks, developing some separated glide blocks.

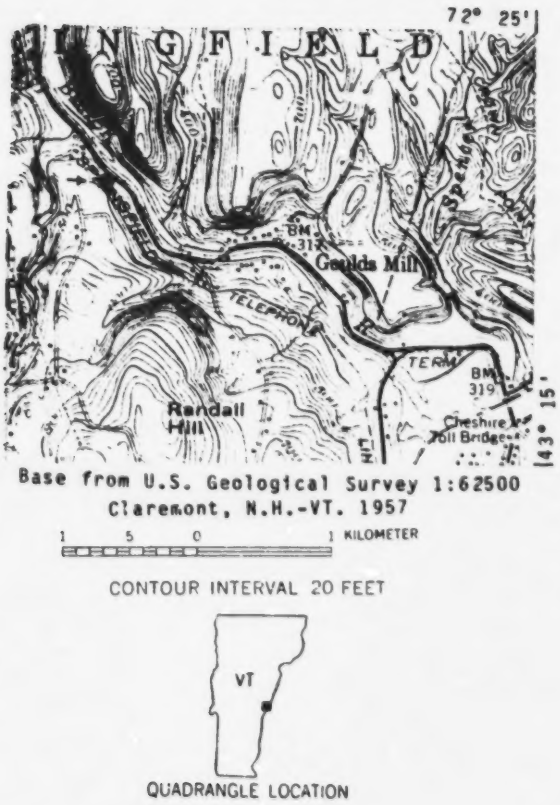
Another earthflow in glacial lake-bottom deposits developed along Vermont Route 11, southeast of the town of Springfield (Loc. 19, Fig. 1 and Fig. 10). The failure occurred on the face of a 80 foot (24.4 m) high terrace on the southwest wall of the Black River valley. Because the failure did not involve the present new alignment of Route 11, no corrective measures were taken, except for the removal of trees on the slide mass which threatened power and telephone lines.

Figure 10. Site 20. Map locating the Vermont Route 11 Slide. Slide is in the upper left of the map at the arrow.

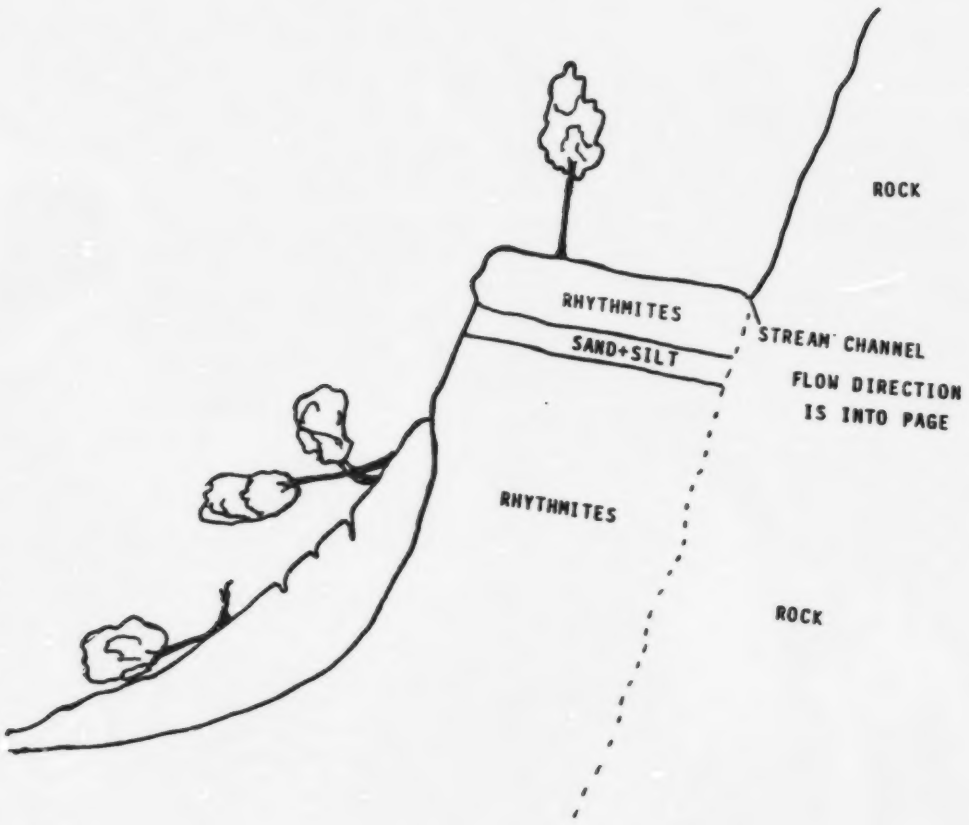
parallel to the bedrock hill. Water from these springs also soaks into the terrace sediments and re-emerges as springs on the terrace front (Fig. 11). In a trench excavated in the scarp face to obtain a clean exposure of the rhythmite sequence, water flowed from the silty sand layers.

Figure 11. Schematic section of the terrace configuration at Vermont Route 11 slide site showing strata and water flow direction.

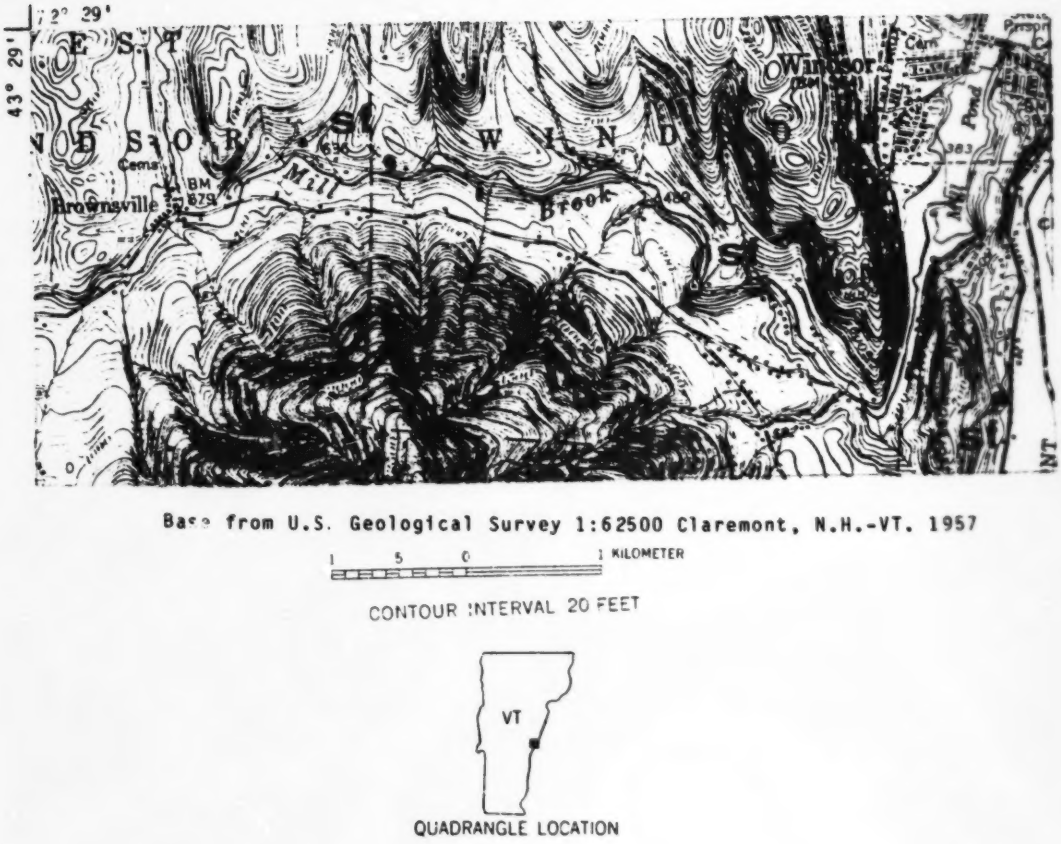
This landslide was located in the Connecticut River valley on the west side of U.S. Route 5 on the east slope of Horseback Ridge just south of the town of Windsor (Loc. 21, Fig. 1 and Fig. 12). The slope failed just after the heavy rains at the end of May 1984. The headscarp had cut halfway across an old overgrown road which runs parallel to Route 5 about 110 feet (33.5 m) upslope. The slope angle below the old road and along the slide axis measured 30° (58%), and the slope angle above the old road was 36° (73%).

When we examined the site on July 24, the saturated failed toe area was still exuding water. Springs were noted to be issuing from numerous locations at the base of the headscarp, and in the scarp areas of the older landslides to the south. These springs marked a level along this entire slope just below the terrace top that defined the contact between an upper aquifer

Figure 12. Map locating the Windsor Route 5 and Brook Road Slides. The letters sf point out the slope failures.

composed of the dark brown gravelly fine sand, and a lower layer of gray clay which was observed in the failed head scarp. Heavy flow from these springs after intense precipitation apparently triggered the slides.

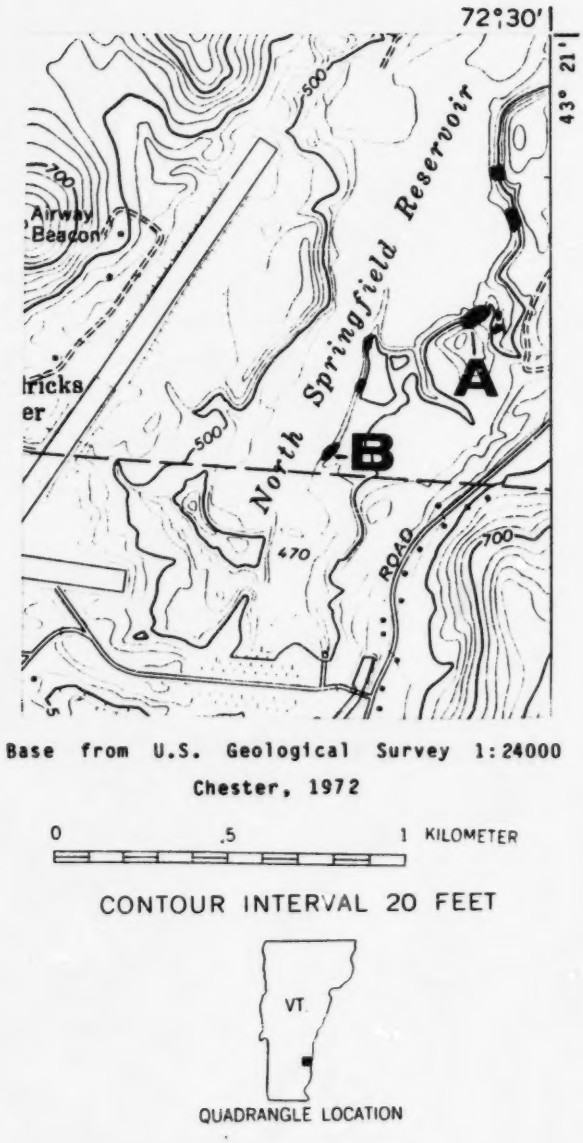
Three older landslide areas on the east slope within the flood pool of the reservoir had been stabilized by the Corps of Engineers. This stabilization was accomplished by grading the slope back to an angle of 26° (approximately a 2 on 1 slope) and the planting of selected types of vegetation. The southern part of the eastern slope was stabilized in two stages beginning in the fall of 1975 and completed in the summer of 1976; the northern part of this slope was stabilized in 1980 (Corps of Engineers resident engineer, (pers. comm., 1985). However, all of these slopes were reactivated in the spring of 1984 along with numerous new slides elsewhere in the basin (Fig. 13).

The failures at North Springfield reservoir can be best classified as earth flows, with some local variations. Two special features found at North Springfield were the configuration of the slide toes and the nature of the deposit. The deposit at one failure studied on the south-east side of the reservoir (A in figure 13) had a clayey sand, gravel and silt layer at the top. These materials were probably stream deposits laid down after the level of glacial Lake Hitchcock dropped. This would make the material which covered the slope face a reworked soil and/or slope wash. A lake-bottom rhythmite sequence underlies these deposits for some 60 feet (18 m). This latter sequence overlays a coarse gravel, cobble, and sand unit. These lower deposits may be those of an esker. The attitude of this lower unit, and the overlying rhythmites, changed along the slope length from north to south as follows: N. 55° E. dipping 30° NW, N. 60° E. dipping 9° NW, and N. 20° E. with a dip of 75° E. These attitudes indicate collapse structures possibly caused by stagnant ice that subsequently melted beneath these deposits. There exists an angular unconformity between the dipping layers and the top strata.

The bottom coarse gravelly deposits provided a zone of high permeability and high shear resistance beneath the slide mass. As was the case with the piping failures at North Hartland reservoir, water entered the coarse materials when the reservoir level was high. When the lake level was lowered, these coarse deposits provided water to the overlying material which was involved in the failure. The coarse bottom deposits did not become part of the slide mass except for slight mixing along the contact; the sliding mass passed over these materials leaving them almost intact.

Toes on failures at the North Springfield site were somewhat different from what was observed at the North Hartland site. At North Springfield, multiple ridges or hummocks of slide material were aligned parallel to the toe, whereas many of the toe areas at North Hartland had relatively smooth surfaces with en echelon tension gashes normal to the slide axis. At the site which was stabilized by the Corps of Engineers closest to the dam, on the east valley wall (B in Fig. 13), the hummocky toe consisted of a rigid layer which buckled upon sliding; small crevasses formed by the buckling became filled with fine grained fluidized material from beneath the flow (Fig. 14A). This buckled layer had the appearance similar to a rug which has been slid against a wall and folded.

Figure 13. Site 7. Map locating the North Springfield Reservoir slide area. A is the location of the slide on the east side of the reservoir at which changes of attitude of the deposit was noticed over the slide length. B is the site of the Corps of Engineers slope stabilization project.

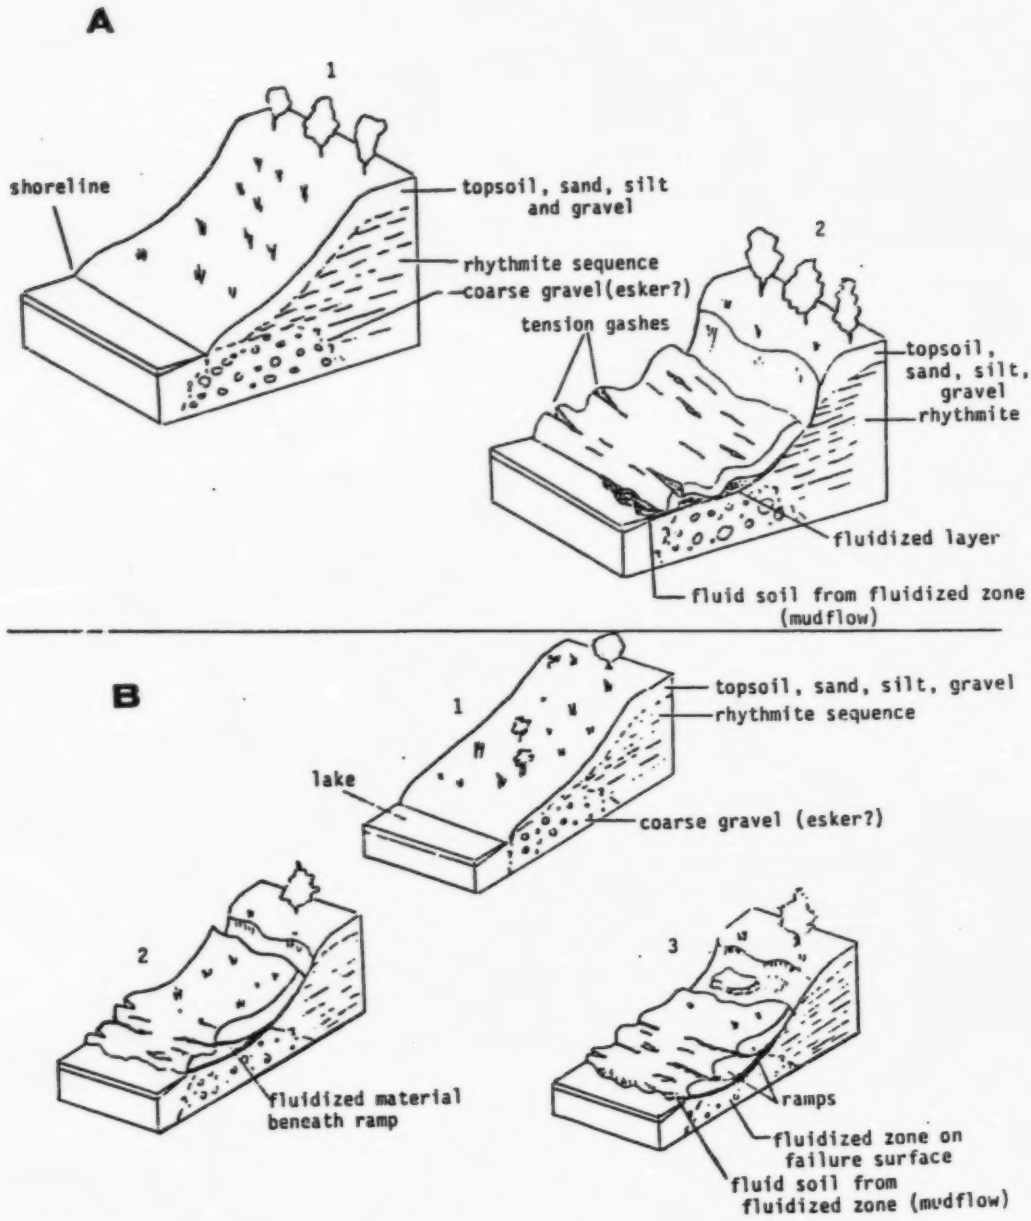
Figure 14. Section sketches depicting the processes for the formation of multiple ridges or hummocks at the east abutment of the North Springfield dam. (A) The hummocks developed in the intact layer are shown with the fine grained fluidized material from beneath penetrating the cracks in the upper layer. (B) Mode of overthrusting and ramping in the toe area of slope movements. These sketches are not to scale.

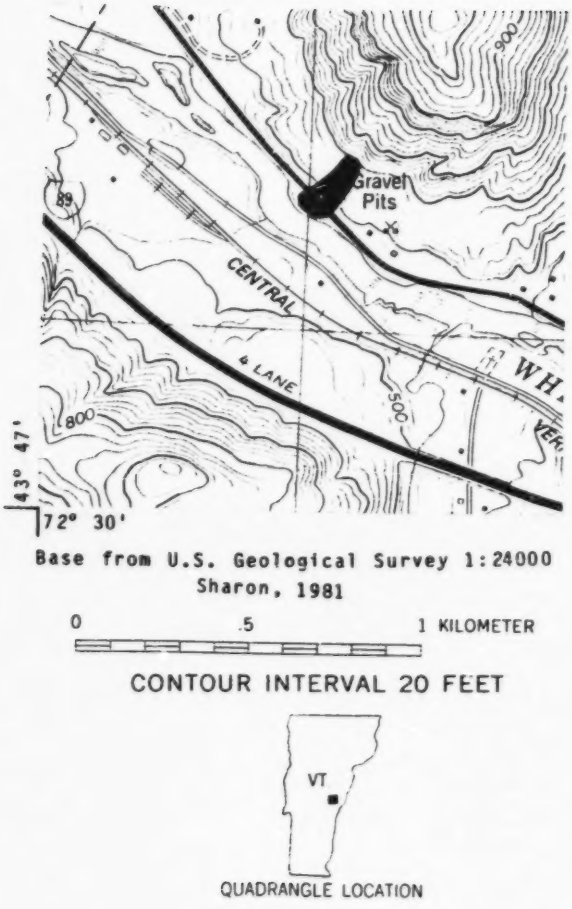
Figure 15. Site 16. Map locating the Sharon slide area.

The rhythmically bedded units at Sharon are glacial Lake Hitchcock bottom sediments. The rhythmite units have a slight dip to the east and are displaced by reverse faults (Fig. 16B) which dip steeply to the west.

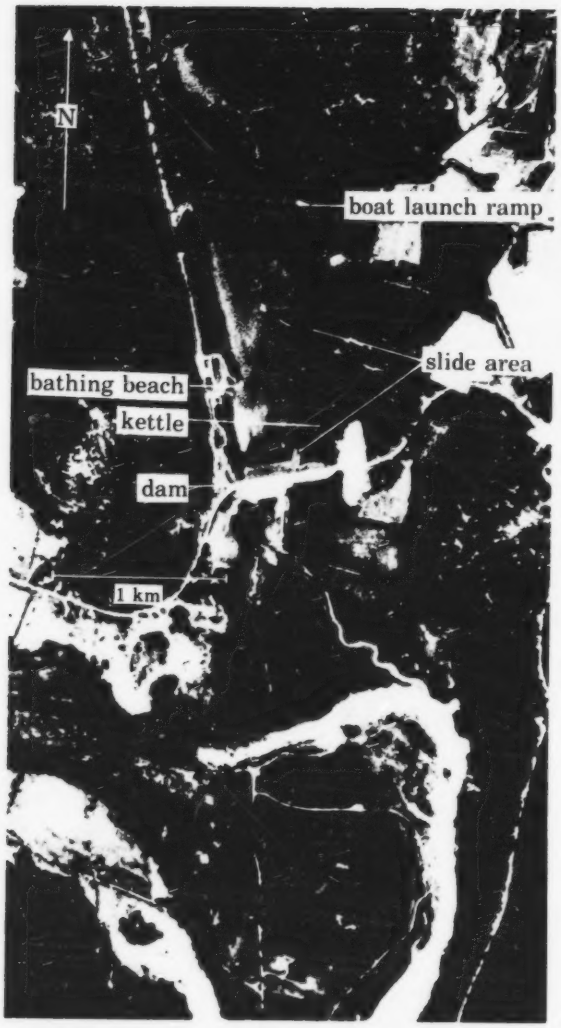
Figure 17. Enlarged portion of an aerial photograph of Stoughton Pond showing the location of slide areas on the east shore. (Photograph courtesy AeroGraphics Corp., Bohemia, N.Y.).

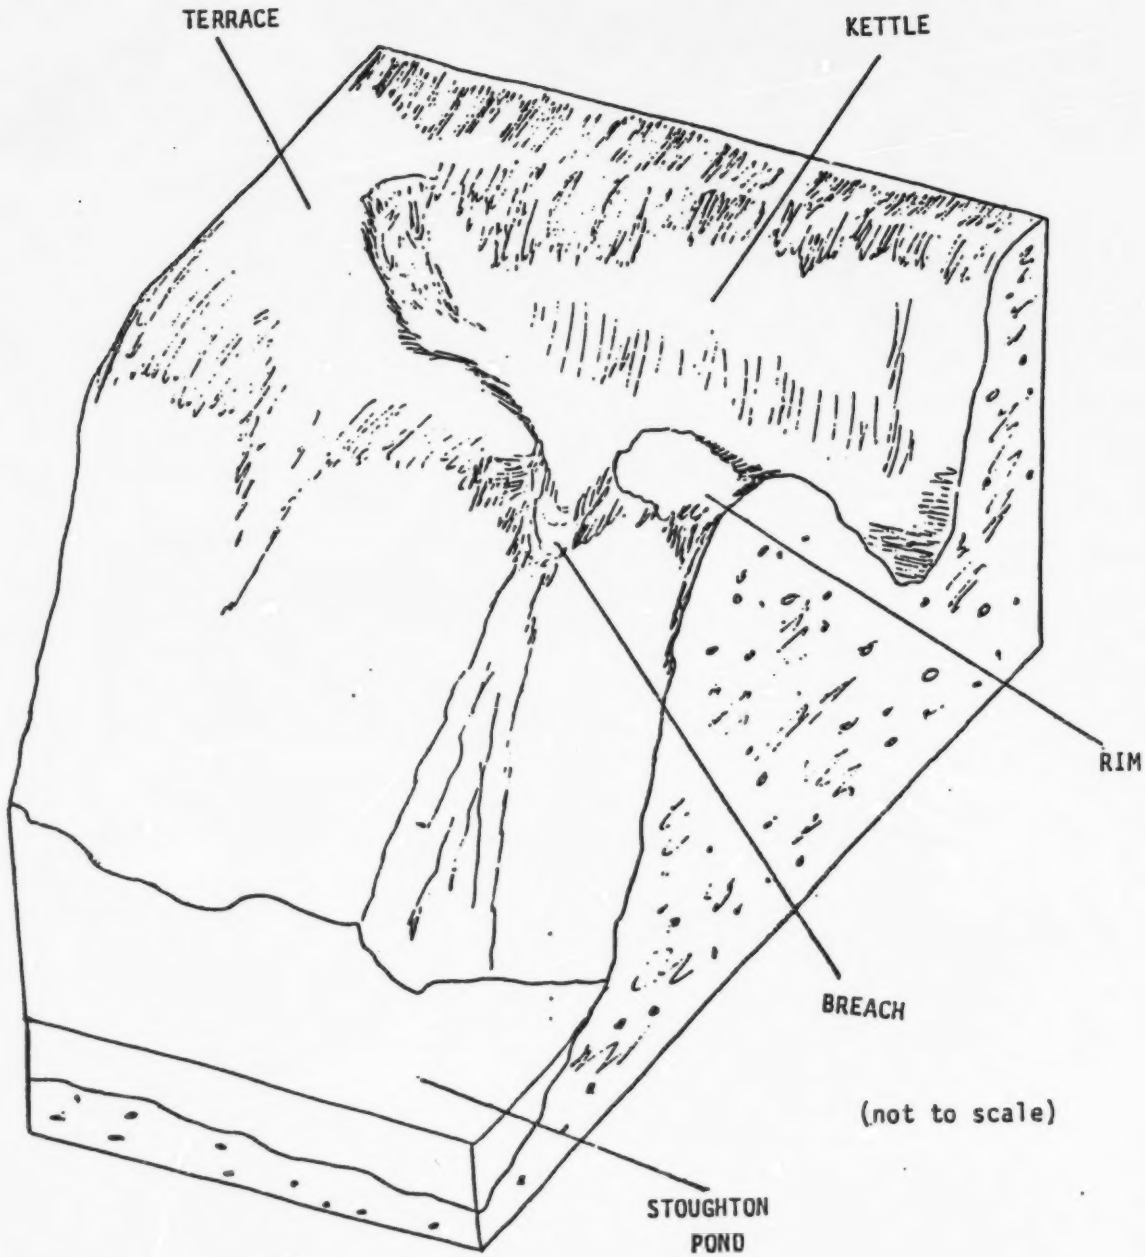
Figure 18. A block-section sketch of a portion of the east shore of Stoughton Pond to show the reservoir terrace kettle rim relationship. This sketch is not to scale.

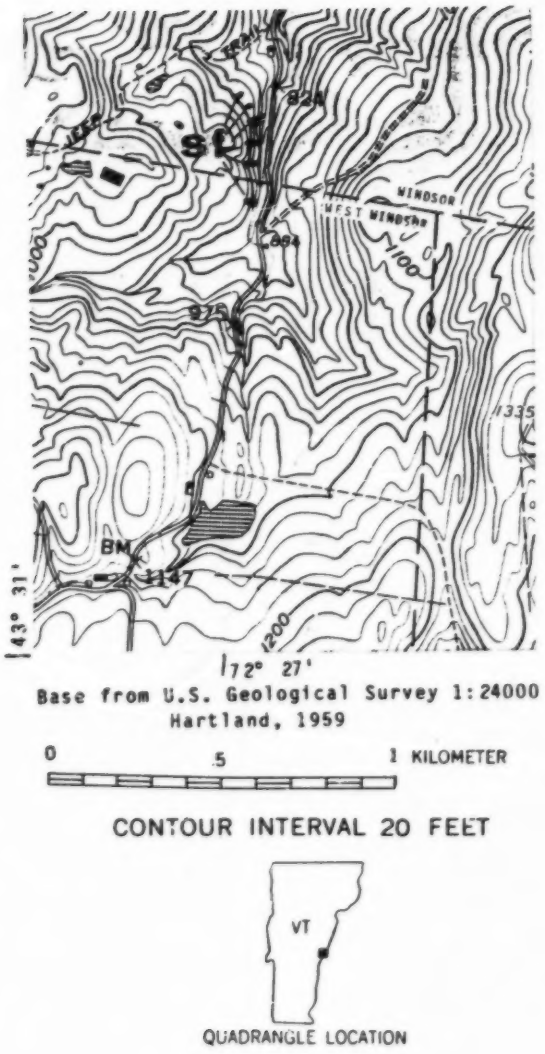
The materials involved in the Holbrook Hill Road slides (loc. 22, Fig. 1 and Fig. 20) were very compact lodgement tills overlain by relatively loose and permeable ablation till with a variable thickness of approximately 60 to over 100 feet (18 to 30.5+ m). Numerous landslides have occurred previously in this valley as indicated by hummocky profiles on the slopes. We noted

Figure 20. Site 23. Map locating the Holbrook Road slide area. The letters sf point out the slope failures.

that several slides in this hummocky terrane were reactivated in the spring of 1984, one of which took out a telephone pole. The head scarp of this latter slide is at the edge of an old abandoned road that is part of a larger interconnected network of abandoned roads upslope of the failure. The road appears to have channeled water from higher elevations into the permeable ablation tills. The ablation till extended for at least 100 feet (30.5 m) upslope from the slide and was composed of a dark brown fine to coarse sand, with 5% (trace) to 30% (some) silt, and fine to coarse gravel and cobbles. These soils were damp at the time of sampling and they had a loose, open texture. The lodgement till underlying the ablation till was composed of gray sticky clay with a trace to some fine to medium sand and gravel, and some cobbles and small boulders.
